**SUBJ:** Emergency Exits

**SAIB:** AIR-22-04

**Date:** March 14, 2022

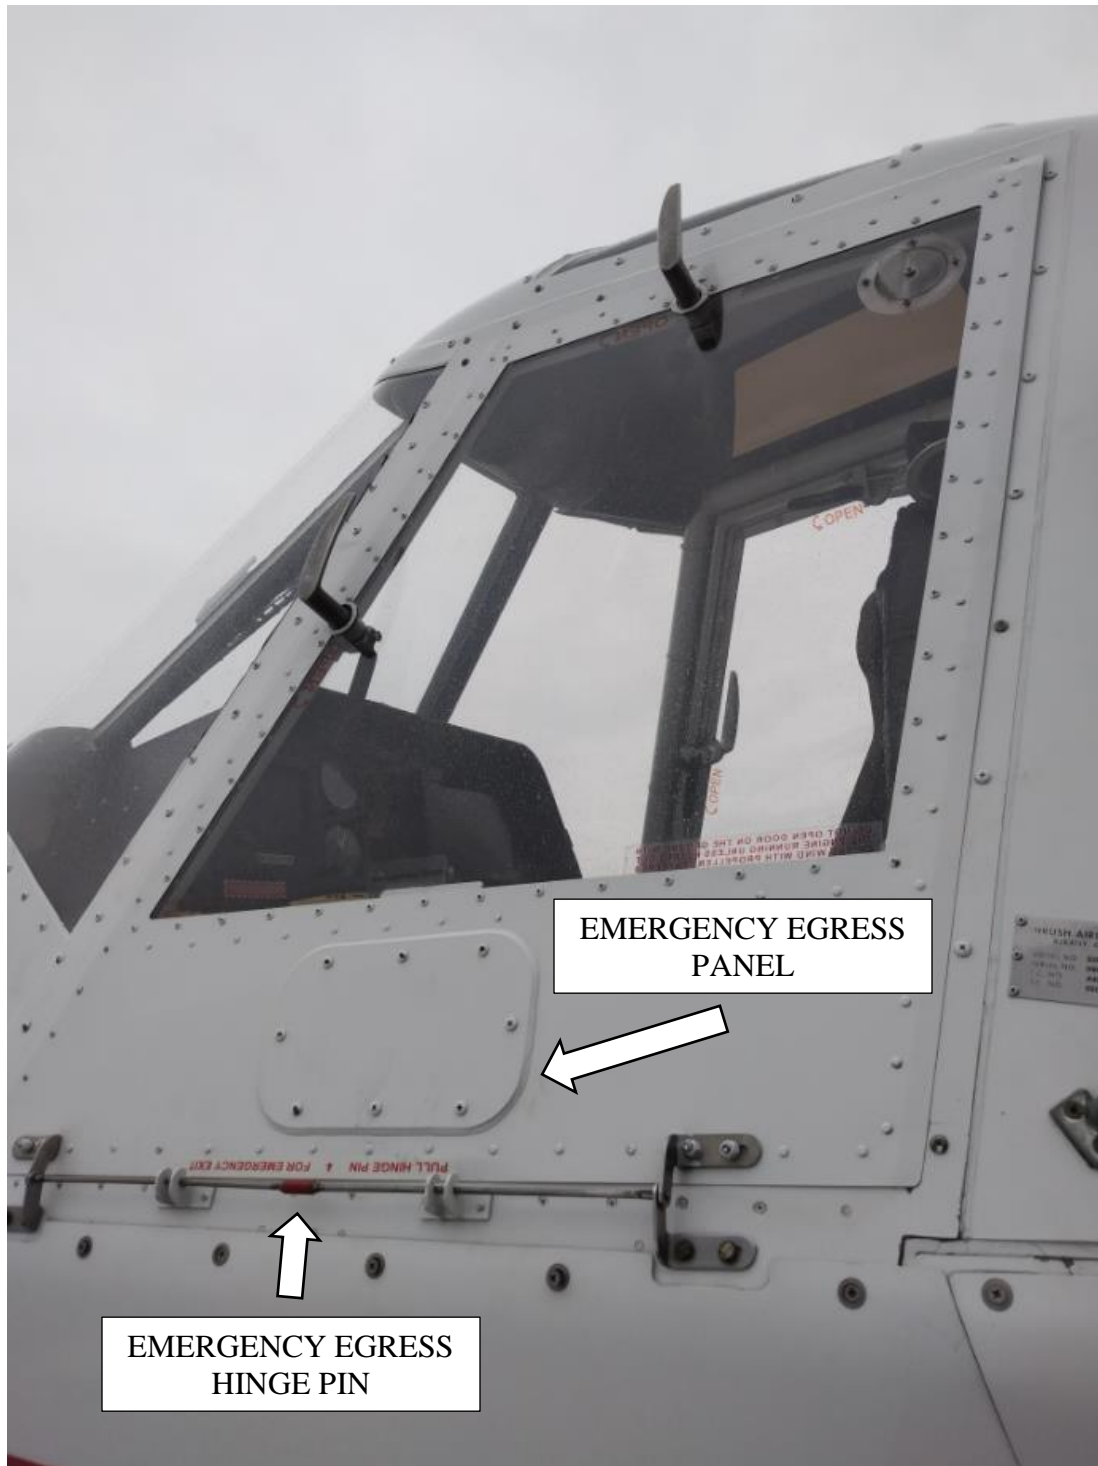
Figure 1. External Egress Panel and Emergency Egress Hinge Pin Assembly

The FAA has received a report of Thrush Aircraft, LLC S2R airplanes having had sealant applied during assembly to the emergency egress panels located on each door. Sealant was applied to prevent water intrusion, but has the unintended consequence of possibly preventing a pilot or occupant from easily pushing through the panel as part of the procedures for emergency egress stated in the airplane flight manual. These procedures require pushing out the panel, reaching through to pull the hinge pin, and pushing the door out.

The issue has since been corrected in manufacturing with a new egress panel assembly. Additionally, Service Bulletin SB-AG-79, dated 01/04/2022, has been released and specifies the necessary procedures for determining if sealant is present and replacing the existing egress panel assembly. See Figures 1 and 2 for location and detail of the emergency egress panel and hinge pin assemblies.

The FAA recommends that all owners and operators of the affected airplanes follow the actions outlined in the referenced service bulletin at the earliest opportunity.
